Risks associated with Hi-Rail vehicles on the rail network

Kirsty Baxter
Manager, Compliance Strategy & Planning

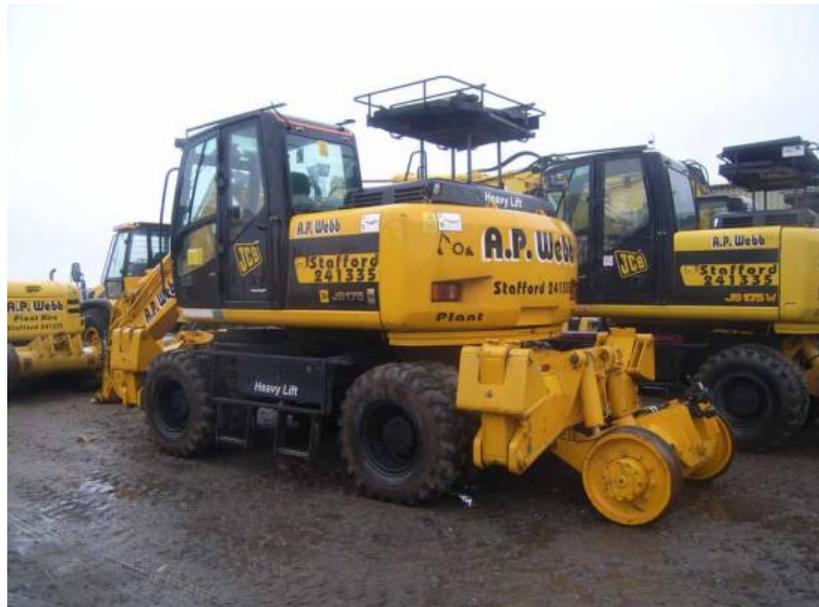
- 1. 9A – Self powered – braking and traction forces are directly transmitted to the rail wheels. See Figure 1 below.

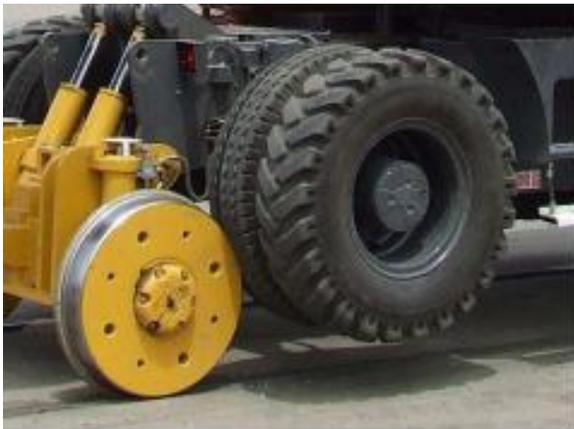
Figure 2: High ride Hi-Rail vehicle with friction drive directly on rail wheels

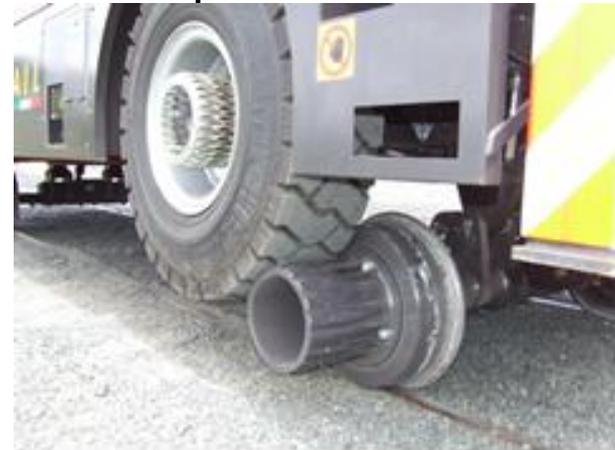
Figure 3: High ride Hi-Rail vehicle with friction drive directly on friction hub or drums fixed to rail wheels

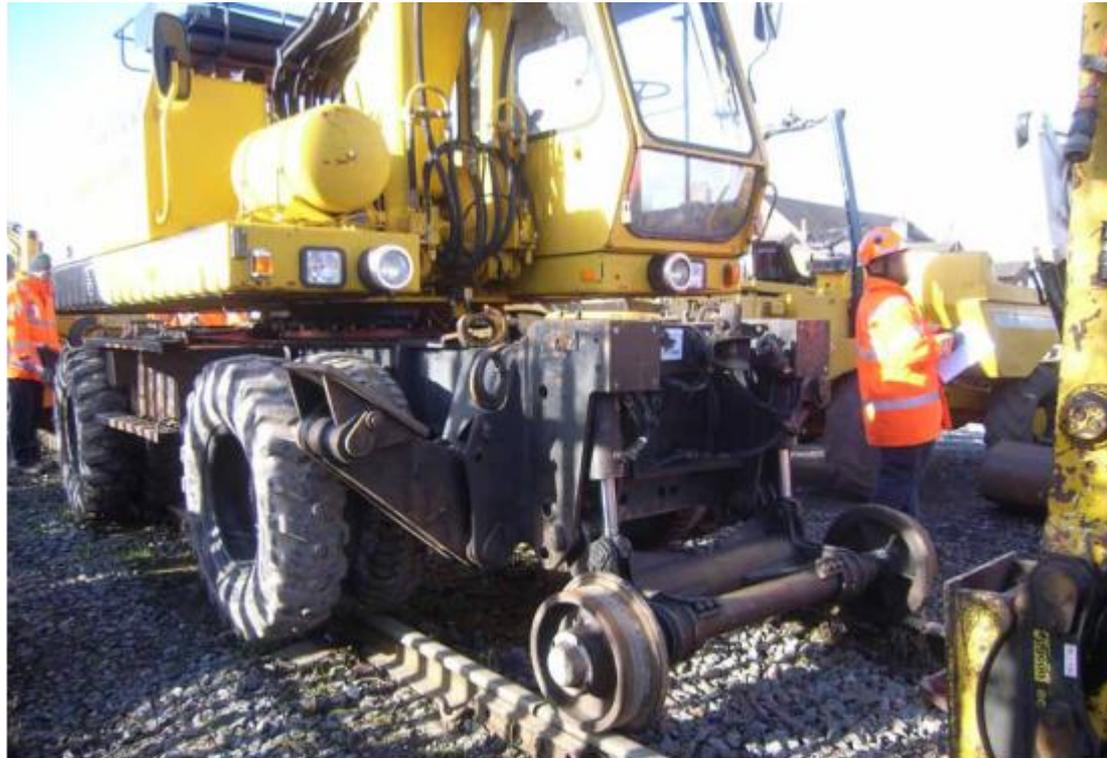
- 3. 9C – Low ride – braking and traction forces directly transmitted to the road wheels through the interface between either the ballast or rail head and the rubber tyres. Furthermore, the load is shared between the road and rail wheels. See figure 4 below for example.

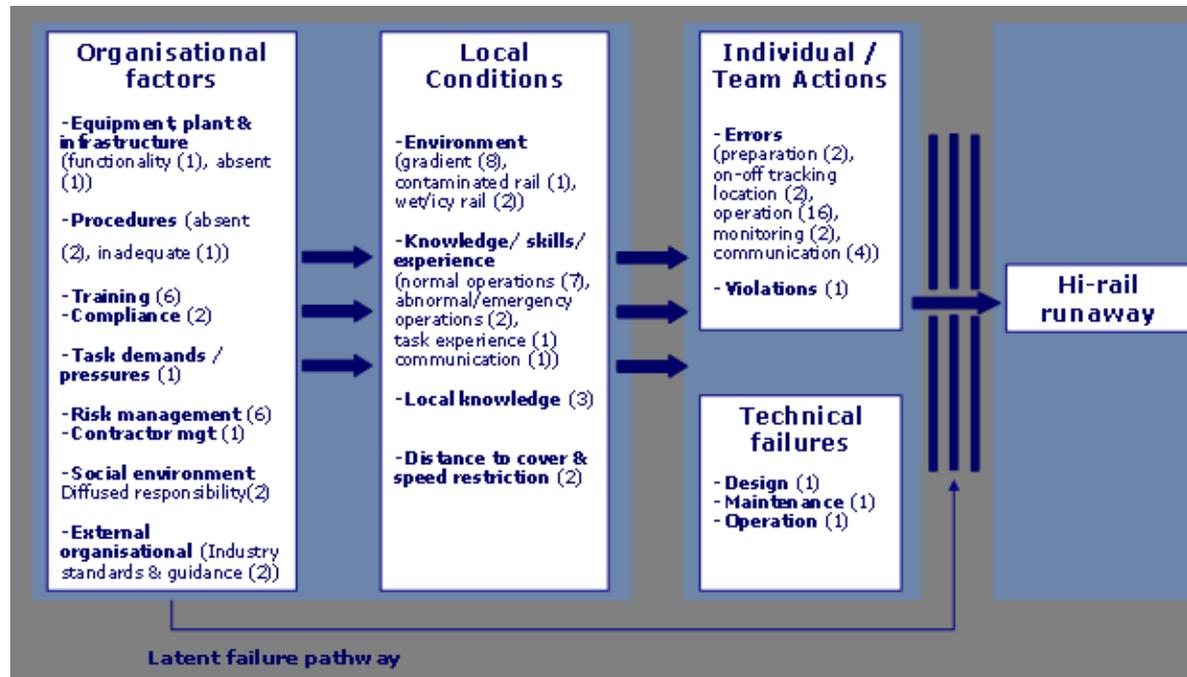
- Diagram below provides an overview of the abovementioned contributing factors based on the CFF (based on Reason's (1997) Model of Organisational Accidents).
- Contributing factors are grouped into individual/team actions, technical failures, local conditions, and organisational factors
